Subject: Petition for Inconsequential Noncompliance with FMVSS 108
2015 MY - 2016 MY Audi A3 Vehicles
Left Rear Turn Signal - Fast Flasher

Part 573 Safety Recall Report

19V-056

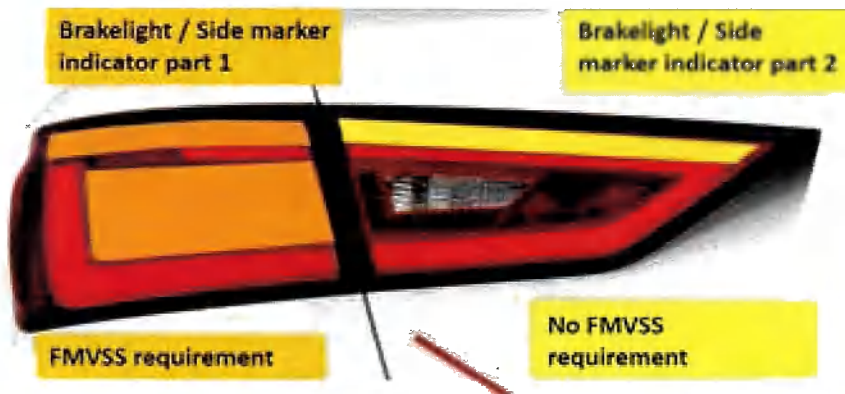
Figure 1: Rear Lamp Assembly

While the turn signal flash rate does not change, indicating an inoperative turn signal bulb, the driver does receive multiple visual / audible warnings indicating a bulb outage, specific to the location of the problem. On the exterior of the vehicle, left turn signal indicator lights are still operational / visible at the left side view mirror and on the left side of the trunk lid (reference Figure 1, Side marker indicator, part 2).

The brake light and indicator light/turn signal are combined; the referenced tail lamp assembly subject to FMVSS 108, is the outboard lighting assembly. The particular condition is limited to the outermost left rear lamp assembly only.

In the case of bulb failure, both lights are then inoperative, including the turn signal. Please reference Figure 1 (Brakelight / Side marker light part 1).

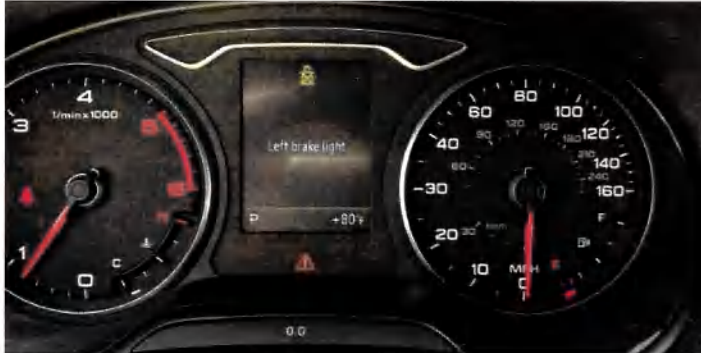
Volkswagen submits that the condition described above is inconsequential as it relates to motor vehicle safety, as the driver receives two different indicator warnings in the instrument cluster immediately upon error.

Please reference driver warnings indicating left turn signal bulb outage, in Figures 2-3:

Figure 2: Indicator that left rear brake light is inoperative

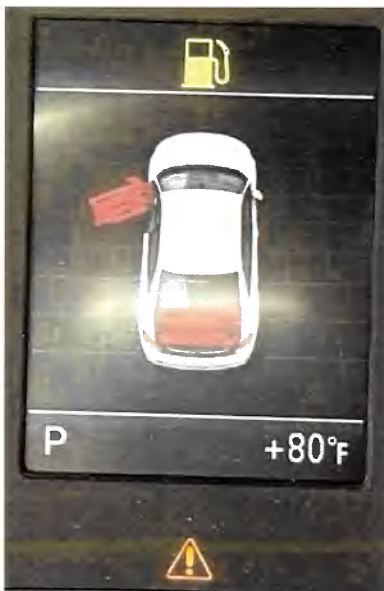
Figure 3: Indicator that left rear brake light is inoperative
